SERVICE *No. 706B* BULLETIN

Date October 9, 1991

SUBJECT: Tail Brace Wire Support Installation

PA-18-150 Super Cub
PA-18-150 Super Cub

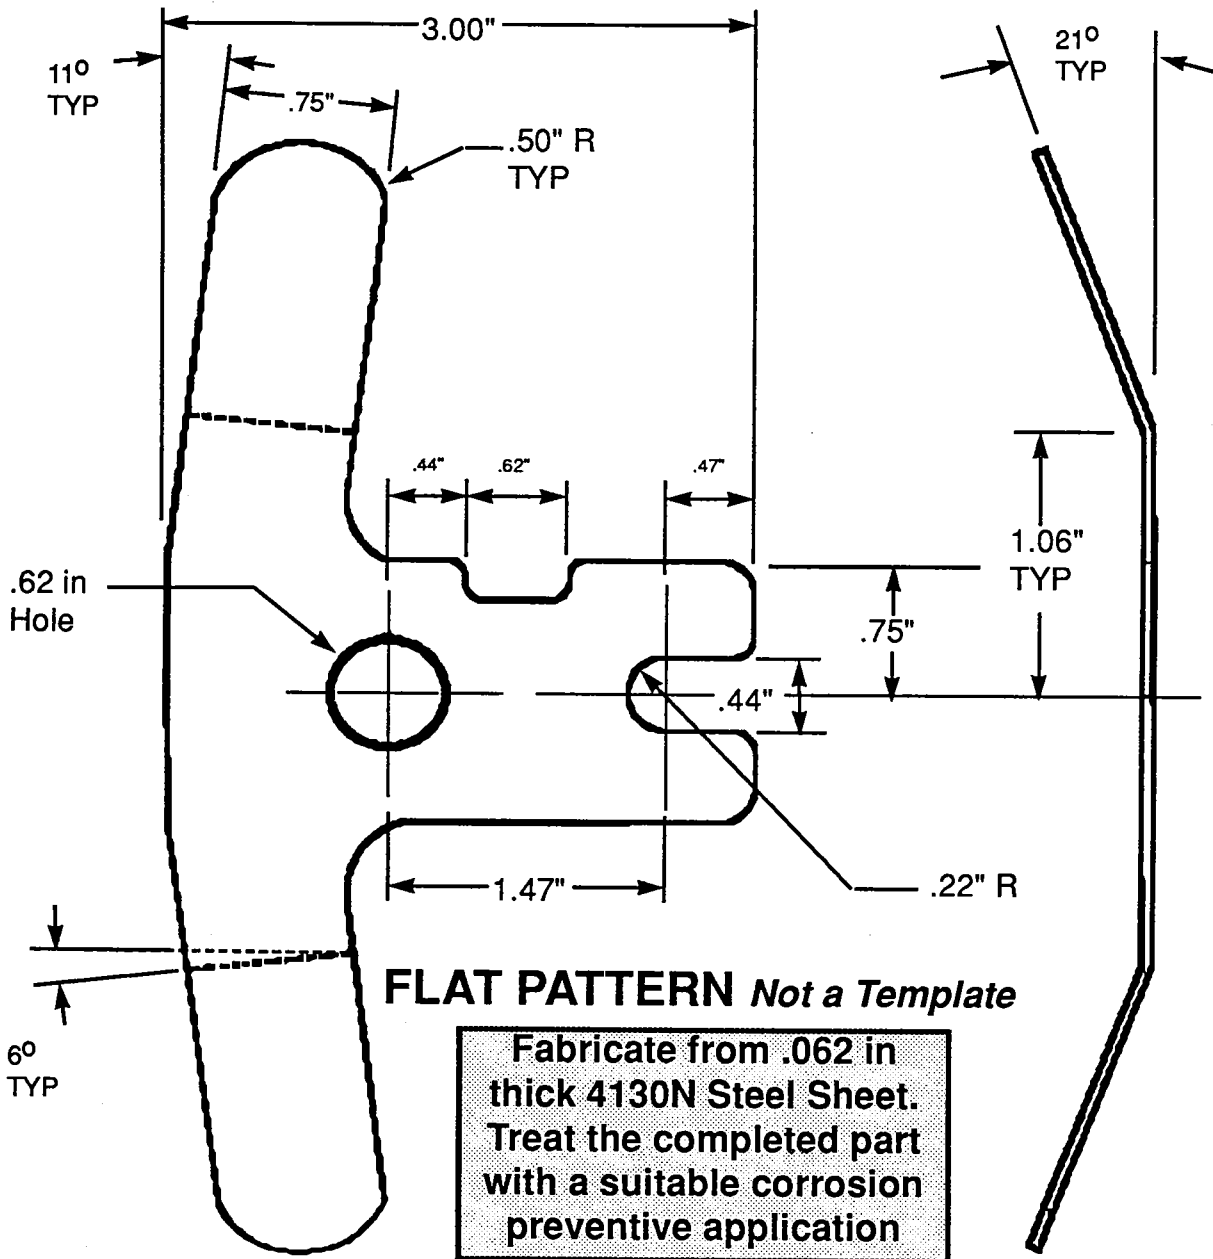
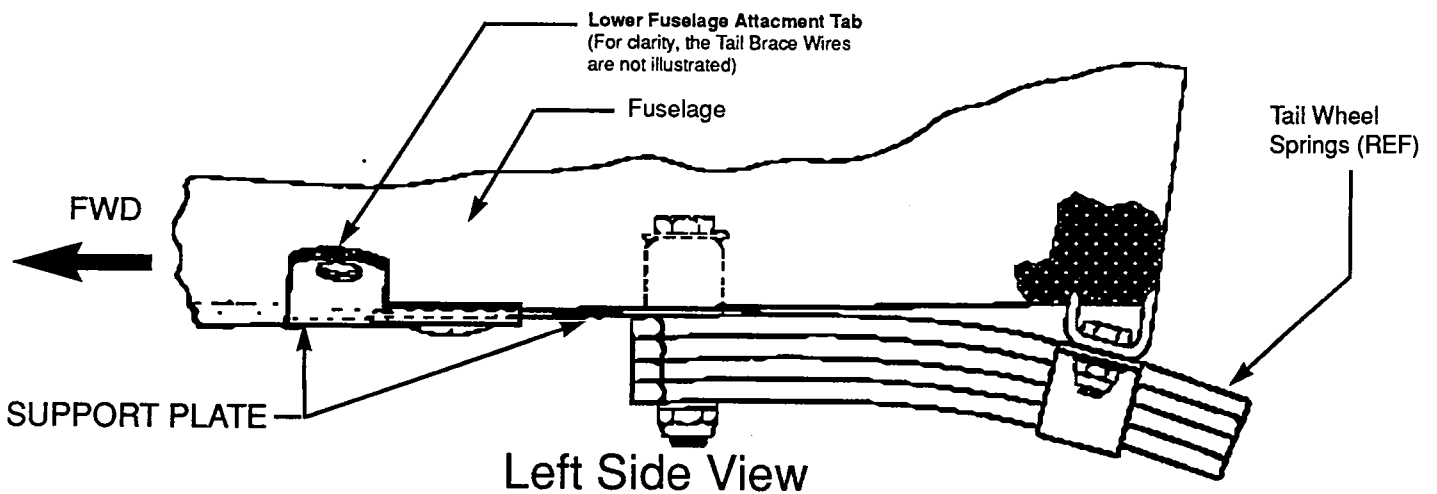
SKETCH A

1. a. For PA-18-150 Super Cub aircraft, Serial Numbers 18-8602 through 18-18-8109013 only, fabricate a support plate from .062" thick 4130 N Steel sheet (6.5" x 3.0") using the template shown on sketch "A", or procure one each, Piper Part Number 60764-02 or Piper Part Number 60764-03 Support Plate.
