Piper Aircraft Corporation
Vero Beach, Florida, U.S.A.

SERVICE No. 706B BULLETIN

Date **October 9, 1991**

SUBJECT: **Tail Brace Wire Support Installation**

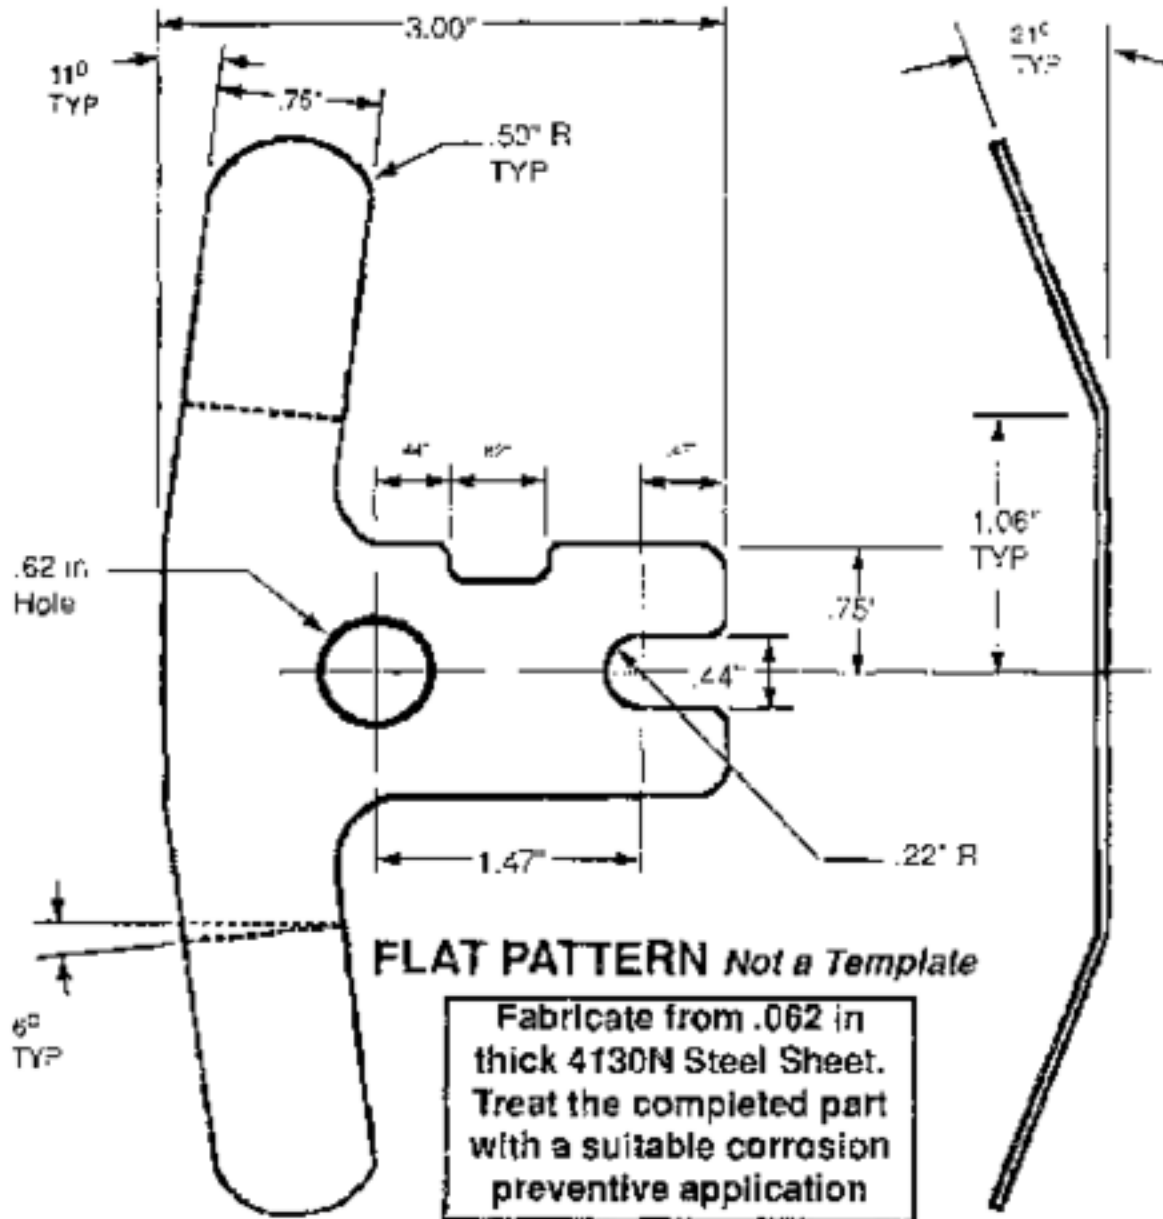
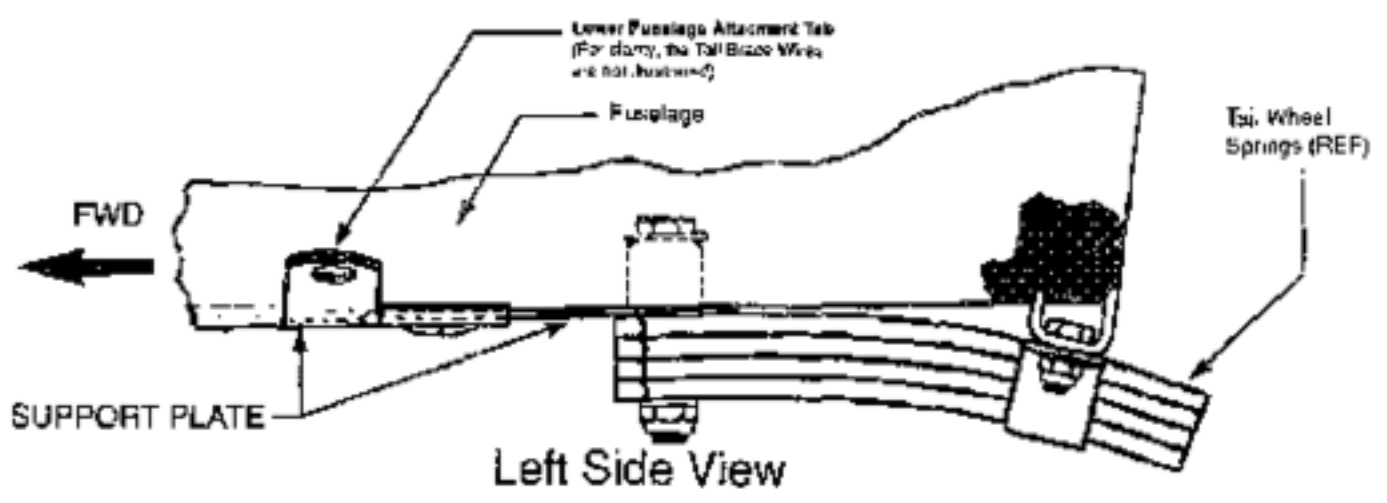
SKETCH A

Reports have been received of failure of the lower horizontal stabilizer brace wire fuselage attachment tab. This tab connects the lower horizontal stabilizer brace wire to the lower fuselage. Separation of the tab and subsequent loss of brace wire support could result in damage to the stabilizer and possible loss of control.

1. a. For PA-18-150 Super Cub aircraft, Serial Numbers 18-8602 through 18-18-8109013 only, fabricate a support plate from .062" thick 4130 N Steel sheet (6.5" x 3.0") using the template shown on sketch "A", or procure one each, Piper Part Number 60764-02 or Piper Part Number 60764-03 Support Plate.
